24x Small-Block Chevy Hardware Installation Guide

Installing the Distributor (Camshaft Signal Adjustment)

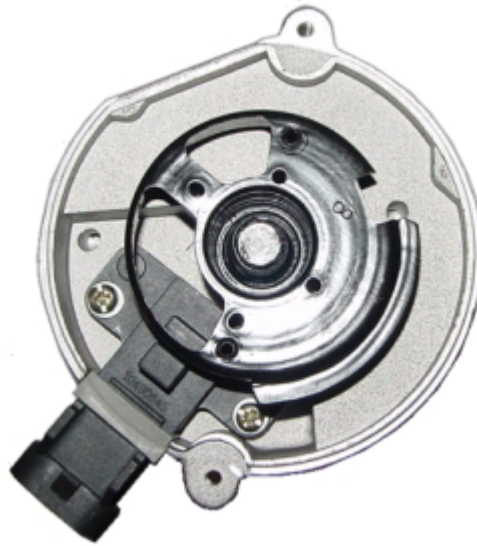
1. Before camshaft sensor installation, rotate the engine to align the timing mark on the timing cover and crankshaft balancer to 0 degrees top dead center (TDC). Also be sure that the number 1 cylinder is on the compression stroke, or that the intake and exhaust valves are closed.
2. Remove the cover from the camshaft sensor (Vortec distributor).
3. Before installation, align reluctor wheel as pictured on right so that the reluctor wheel cutout is in approximately the two o'clock position. This is not the proper alignment for final installation, but should help to provide proper alignment after the distributor is inserted into the engine.

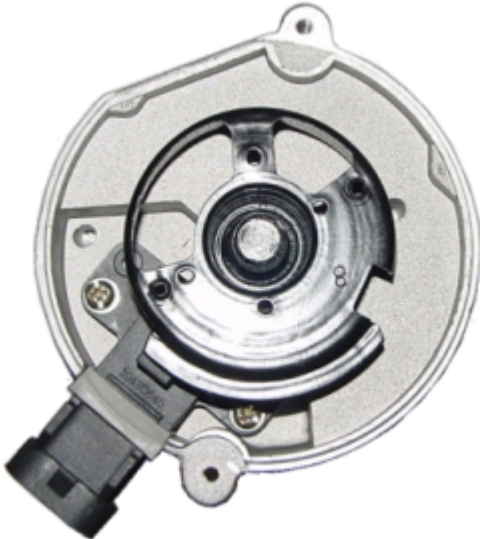
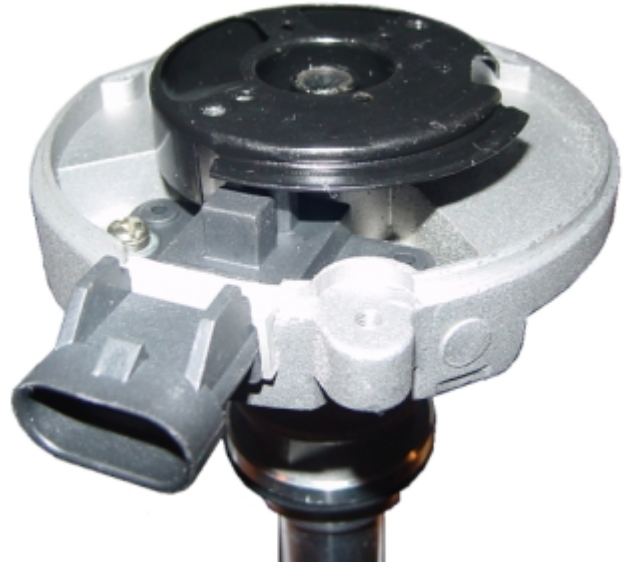
4. Allowing the reluctor wheel to rotate freely, install the distributor into the engine until the distributor is seated on the intake manifold. The reluctor wheel will turn clockwise as the distributor gear engages with the camshaft gear.
5. Once seated, you can turn the distributor housing to change camshaft position. When properly installed, the reluctor wheel cutout should be in approximately the four o'clock position as pictured below.
