The following information will be important for you to understand before the installation of your 58x system.

58x Small-Block Chevy Hardware Installation Guide

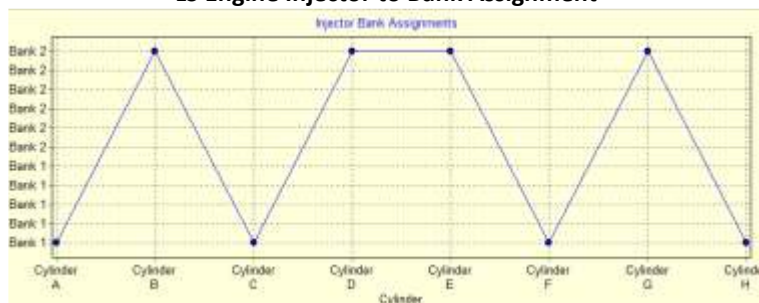
LS Engine Injector to Bank Assignment

For proper Closed Loop operation, bank-to-bank fueling can be corrected through the PCM calibration by assigning the appropriate injector to each bank. The images below represent the “Injector Bank Assignments” table in EFILive, calibration table B1519.

The LS series engines have a different firing order than the early small-block Chevy engines. Specifically, cylinders 2&3 and 7&4 have been swapped. If you are building your own engine harness, be sure that you swap injectors and coils 2&3 and 7&4 at the PCM. If you have ordered a new engine harness from EFI Connection, the harness has been built in this way.

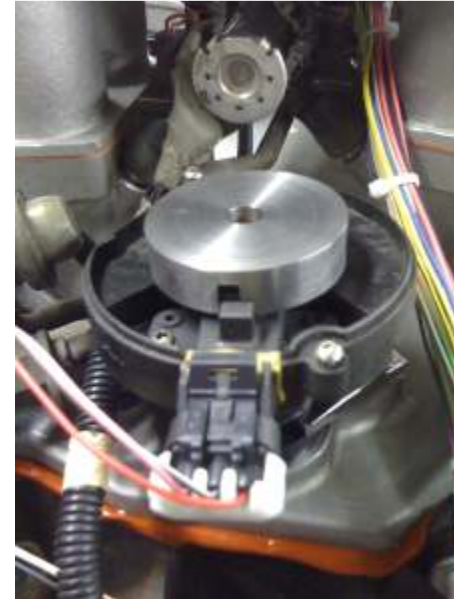
Installing the Distributor (Camshaft Signal Adjustment)

The Gen IV LS engines have a fixed cam signal with no adjustments, but the EFI Connection 4x distributor assembly allows 360 degrees of adjustment. We have found that the best orientation is as shown while number 1 piston is up.

Because GM provides no information regarding proper alignment, our recommendation is to roughly set the cam signal as mentioned above and then monitor for P0016 and poor starts. Adjust the cam signal until P0016 does not set and the engine starts without backfire or extended cranking.
